December 8, 2020

SUBJECT: **Customer Satisfaction Program 20N11**
 Certain 2016 - 2019 Model Year Explorer Vehicles equipped with a Roof Rail
 Roof Rail Cover Detachment

REF: **Technical Service Bulletins 19-2364 and 20-2154**
 2016-2019 Explorer – Roof Rail Covers Loose

CERTAIN 2016-2019 MODEL YEAR EXPLORER VEHICLES — ROOF RACK REPAIR

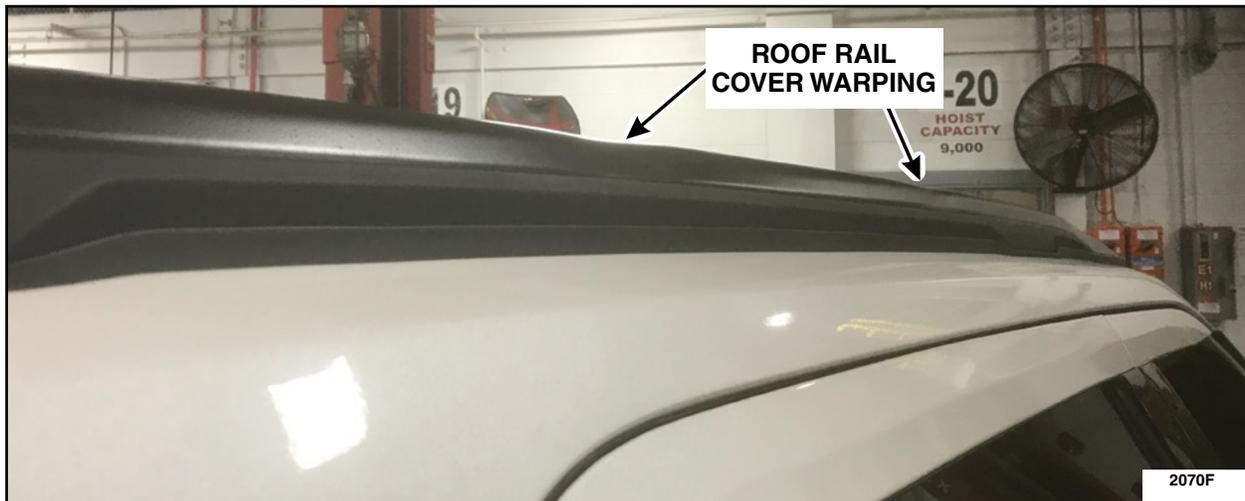
FIGURE 1

1. Inspect for roof rail covers that are missing, broken and or show signs of warping. See Figure 1. Are either one or both of the roof rack covers missing, broken and or show signs of warping?

If **YES** - Take a photo of the roof rail cover on the vehicle, remove and discard the roof rail cover as a *new* one will be installed. Proceed to Step 4.

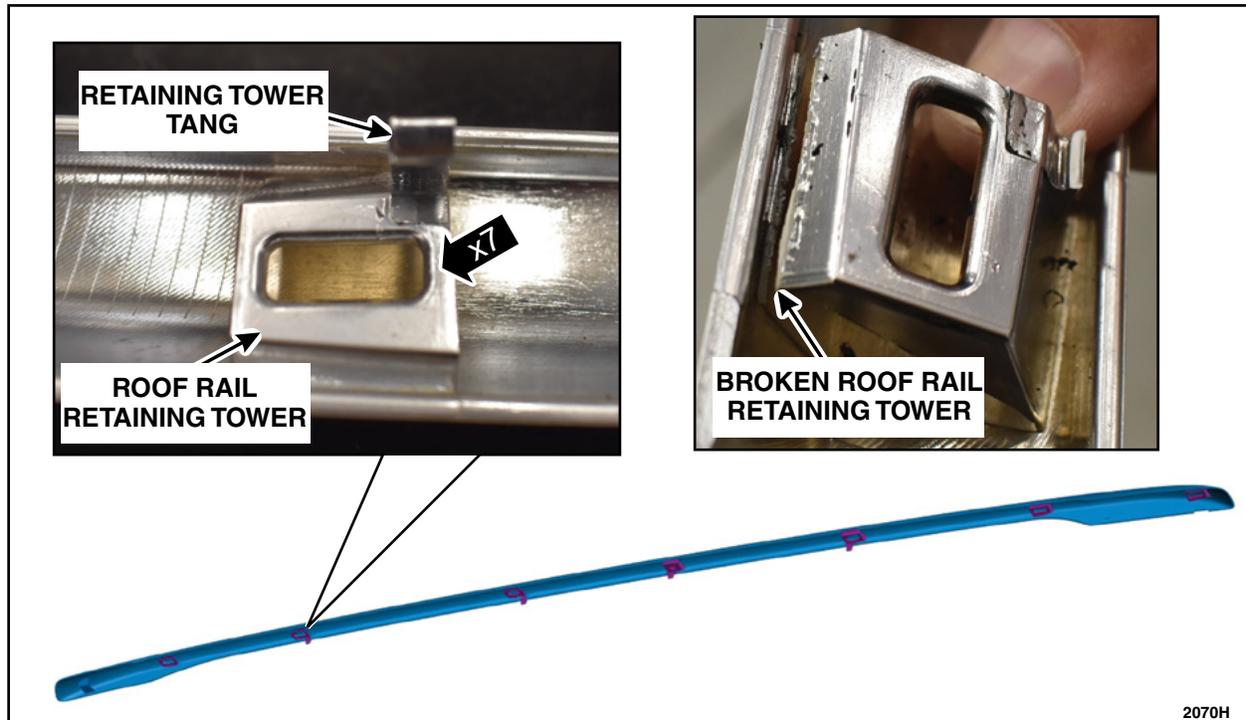
FIGURE 3

NOTE: The tangs on the retaining tower can be broken and do not qualify as a broken retaining tower.

3. Inspect the roof rail cover retaining towers and front tab. Are any of the seven retaining towers or front tab missing and or broken? See Figure 3.

If **YES** - Take a photo of the broken retaining towers, discard the roof rail cover and replace with a *new* one. Proceed to Step 4.

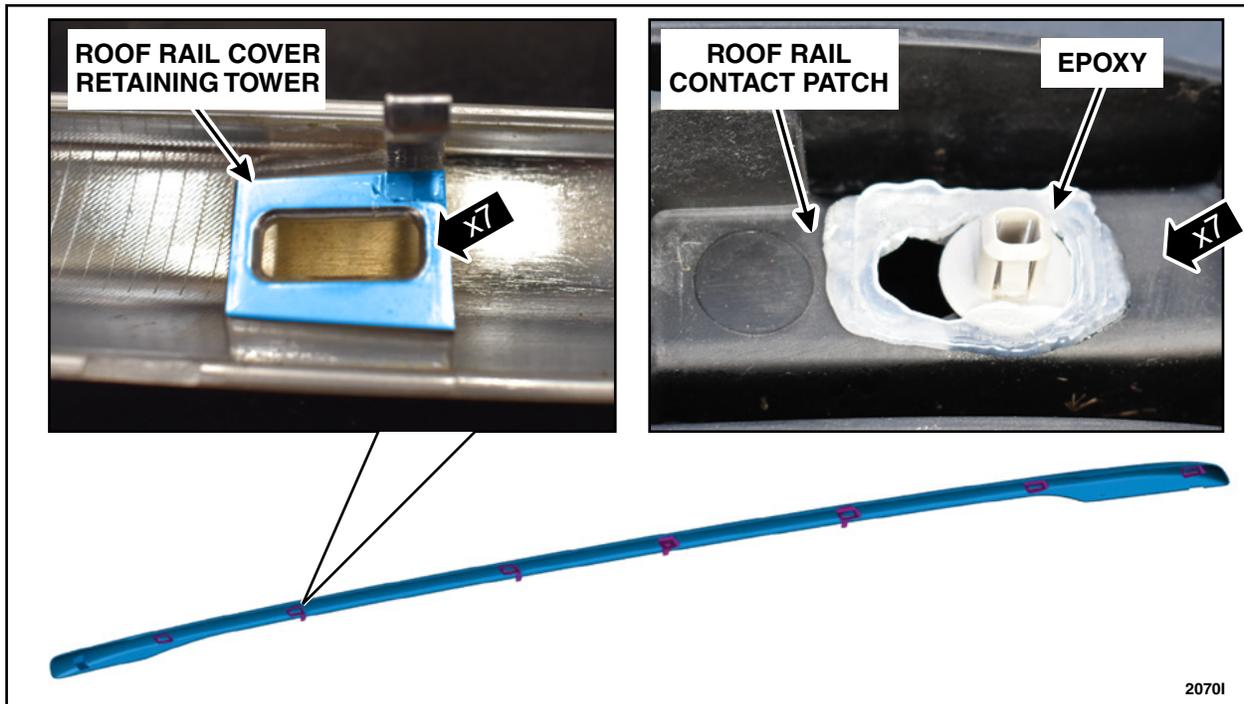
FIGURE 4

4. If Technical Service bulletin (TSB) 19-2364 or 20-2154 was performed, evidence of RTV or epoxy will be seen on the roof rack cover and or roof rail contact patch. Inspect the roof rack cover retaining tower and roof rail contact patch for signs of RTV or epoxy adhesive. See Figure 4. Was evidence of RTV or epoxy found?

5. Remove any adhesive on the roof rail cover retaining tower and roof rail contact pads. See Figure 5.

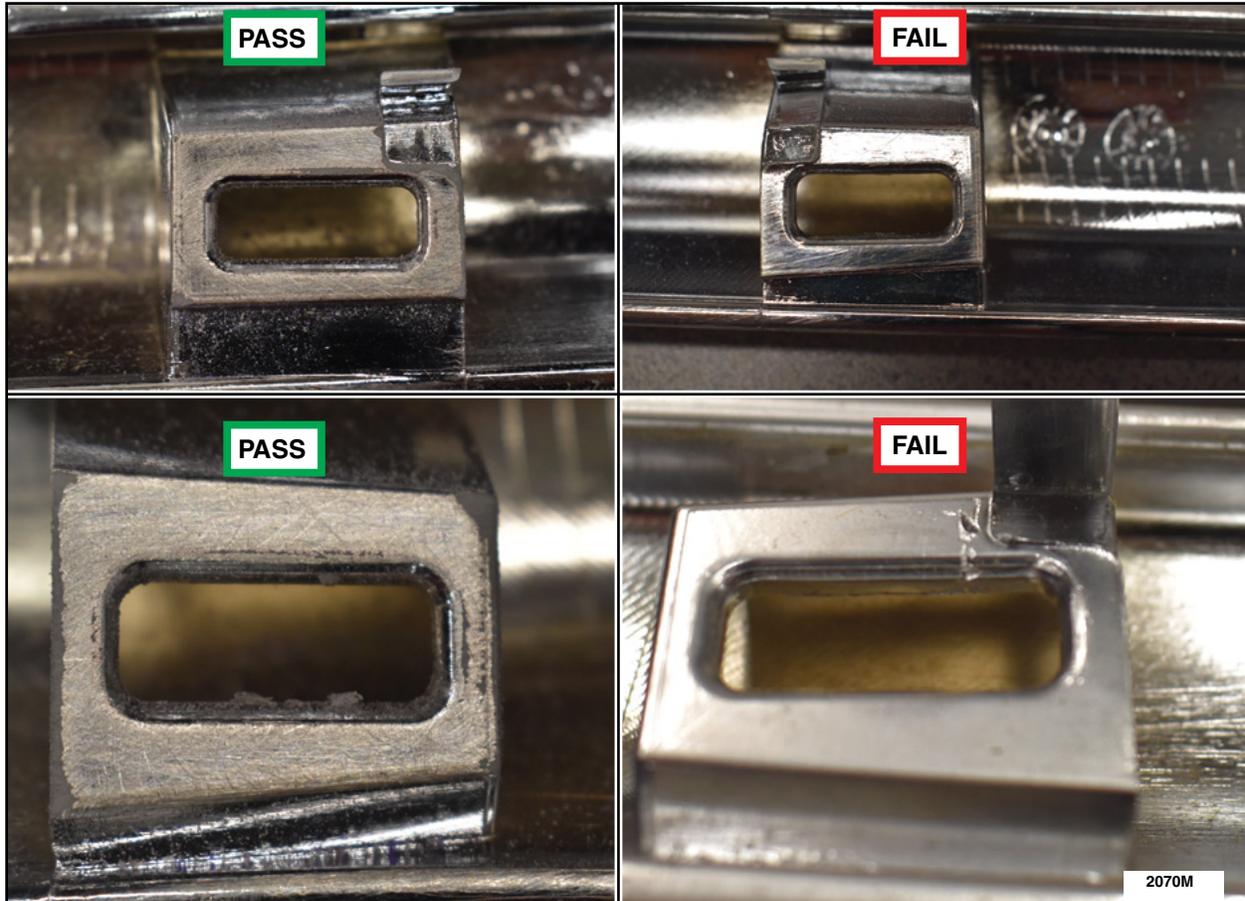
FIGURE 8

8. Without proper abrasion the adhesive will not hold. See Figure 8. Has proper abrasion been achieved?

If **FAIL**, requires more scuffing, go back to Step 7.
